**SAFETY COMPLIANCE TESTING FOR FMVSS 201U**  
**Occupant Protection In Interior Impact**  
**Upper Interior Head Impact Protection**

**FUJI HEAVY INDUSTRIES, LTD.**  
**2005 Subaru Outback 4-Door Wagon**  
**NHTSA No. C55501**

**FINAL REPORT**

1. Report No. 201U-MGA-05-02		2. Government Accession No.		3. Recipient's Catalog No.	
4. Title and Subtitle Final Report of FMVSS 201U Compliance Testing of a 2005 Subaru Outback 4-Door Wagon, NHTSA No. C55501				5. Report Date December 3, 2004

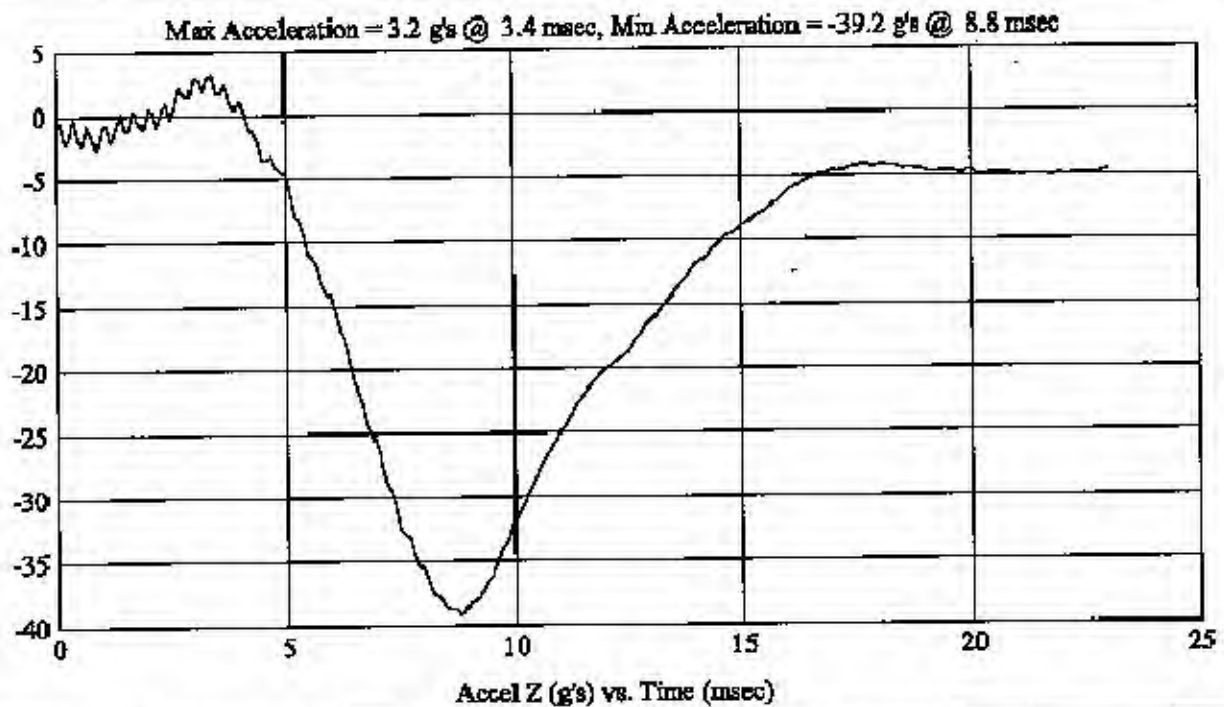
Model Year: 2005  
Target: AP1  
Vehicle Side: Right  
Horz/Vert Angle: 108/29

HIC(d) = 358, HIC = 254, Delta T = 6.4 msec

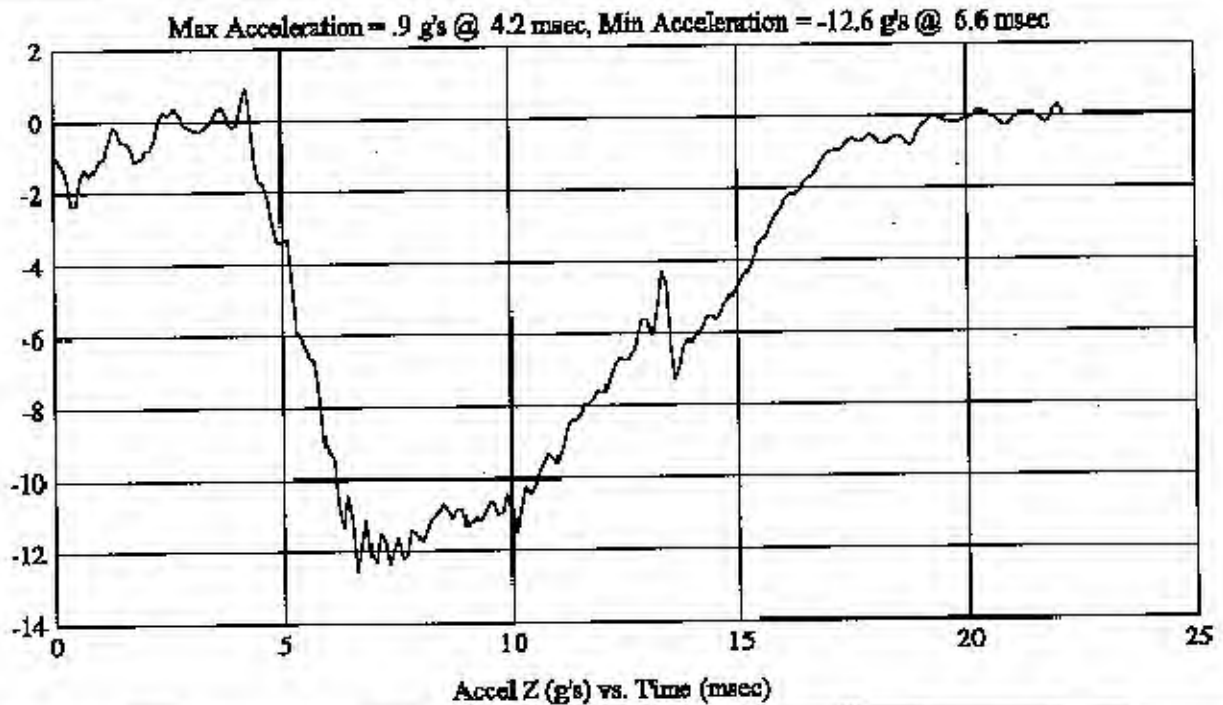
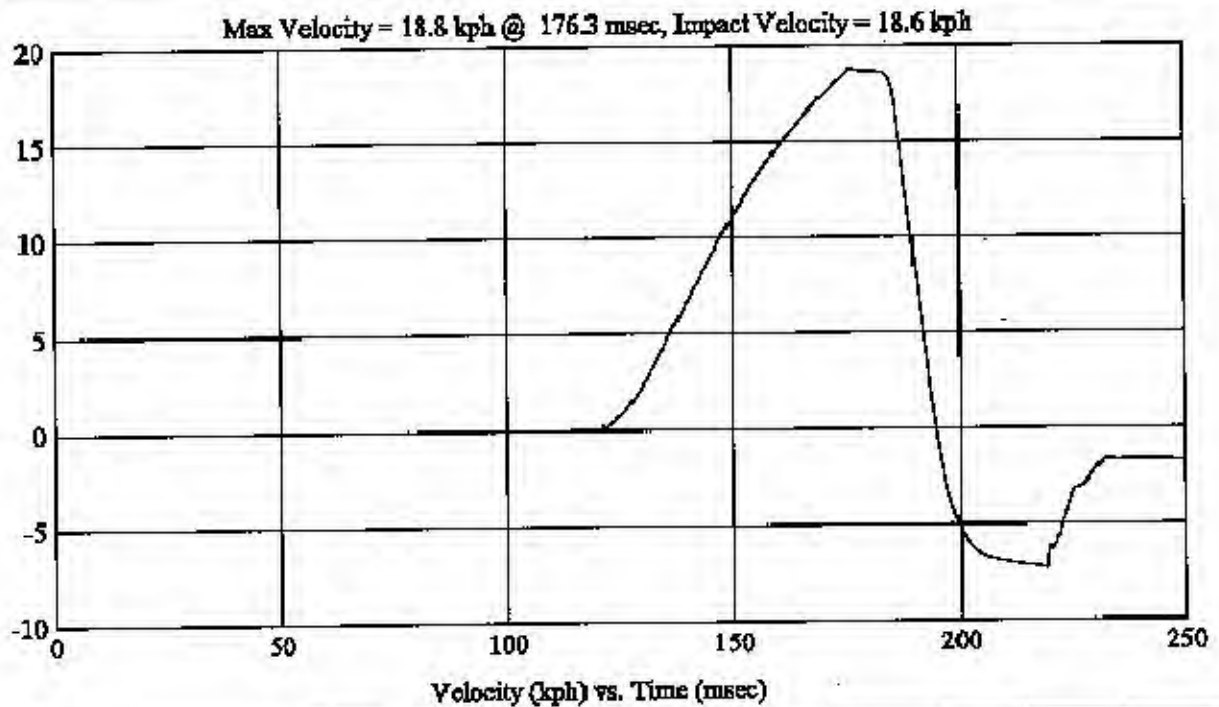
Model Year: 2005  
Target: AP2  
Vehicle Side: Left  
Horz/Vert Angle: 204/46

HIC(d) = 334, HIC = 222, Delta T = 11.6 msec

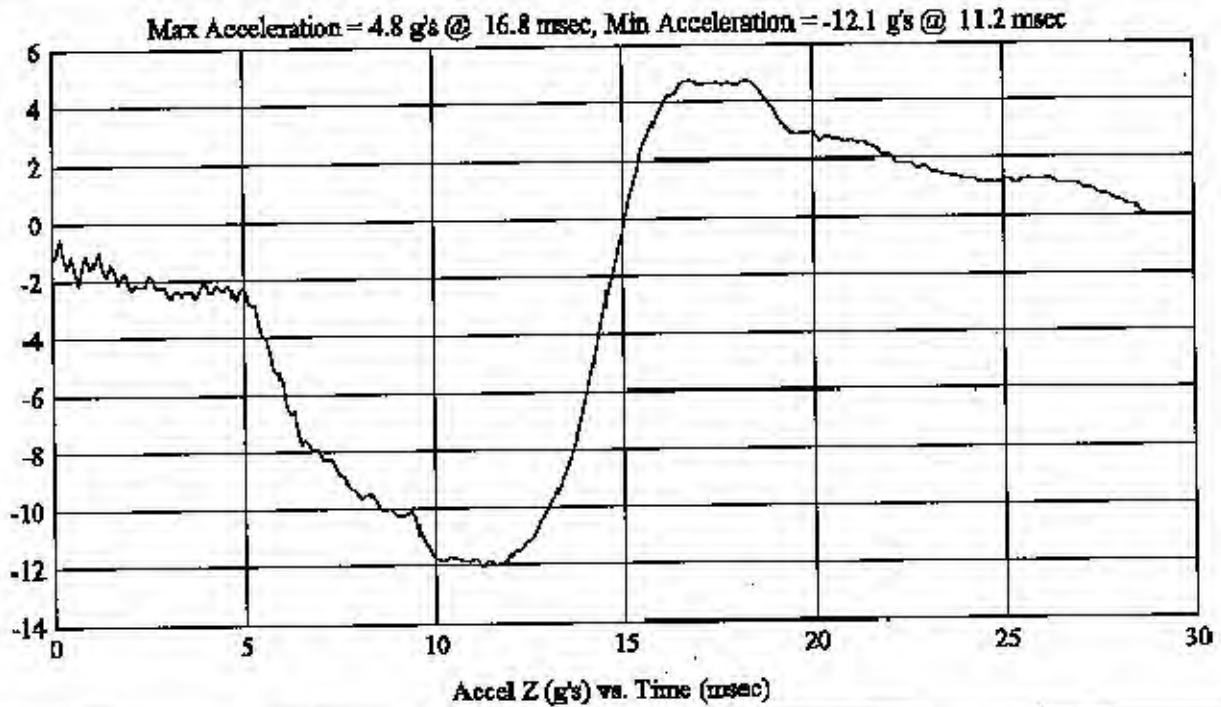
Model Year: 2005  
Target: AP3  
Vehicle Side: Right  
Horz/Vert Angle: 156/45

HIC(d) = 322, HIC = 206, Delta T = 14.2 msec

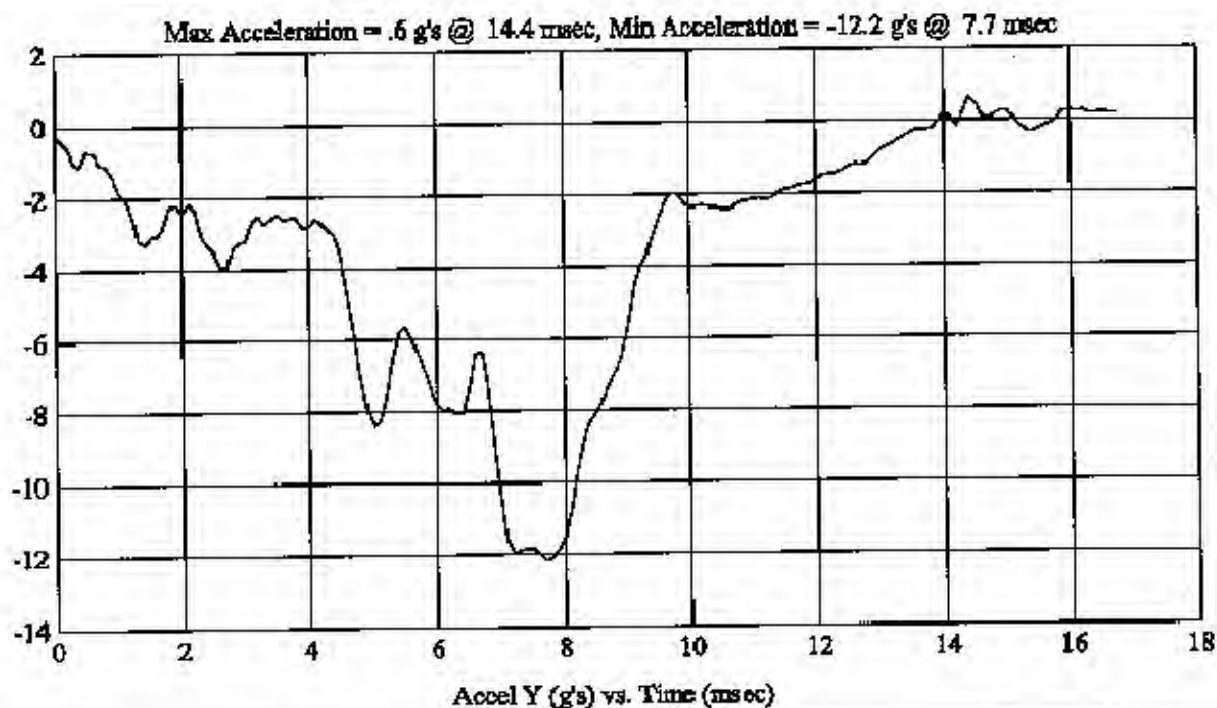
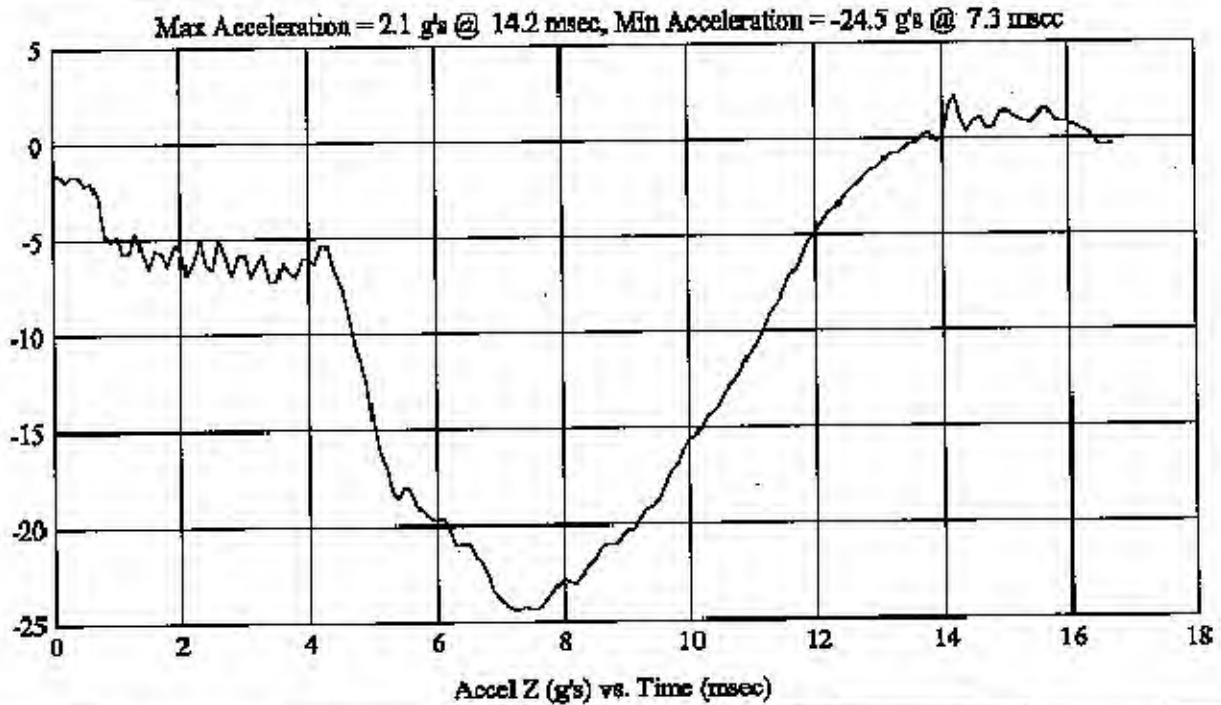
Model Year: 2005  
Target: BP2  
Vehicle Side: Right  
Horz/Vert Angle: 90/7

HIC(d) = 635, HIC = 621, Delta T = 9.3 msec

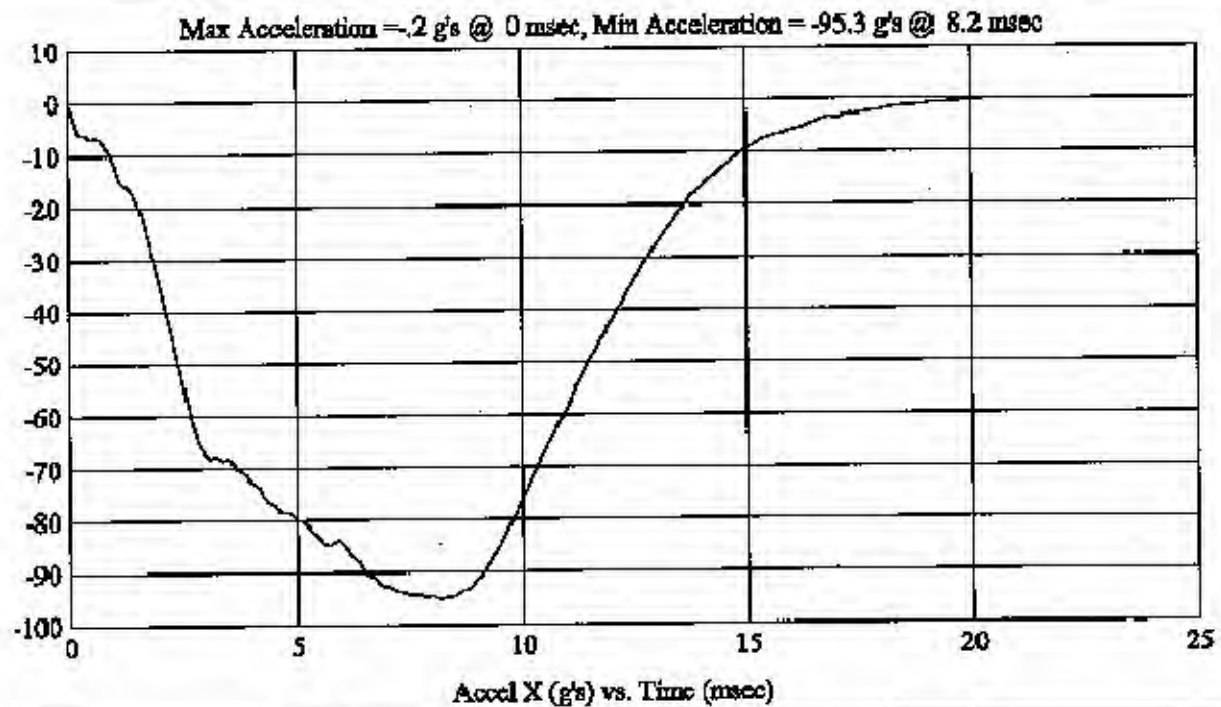
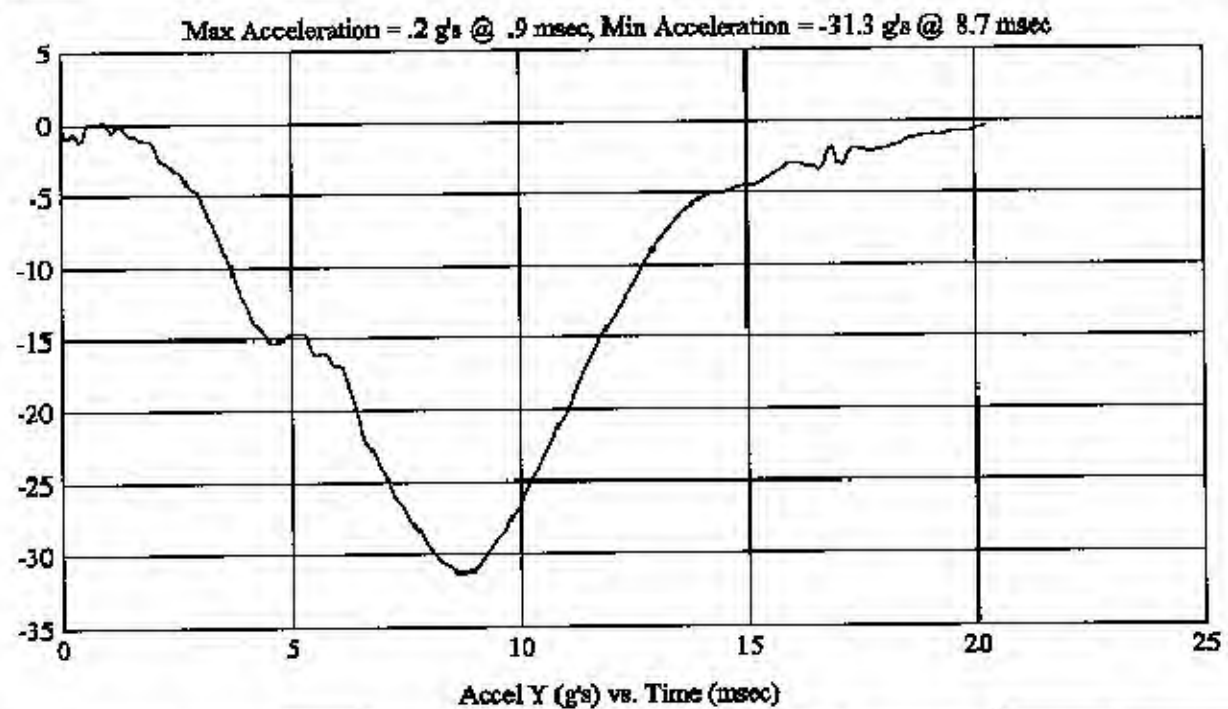
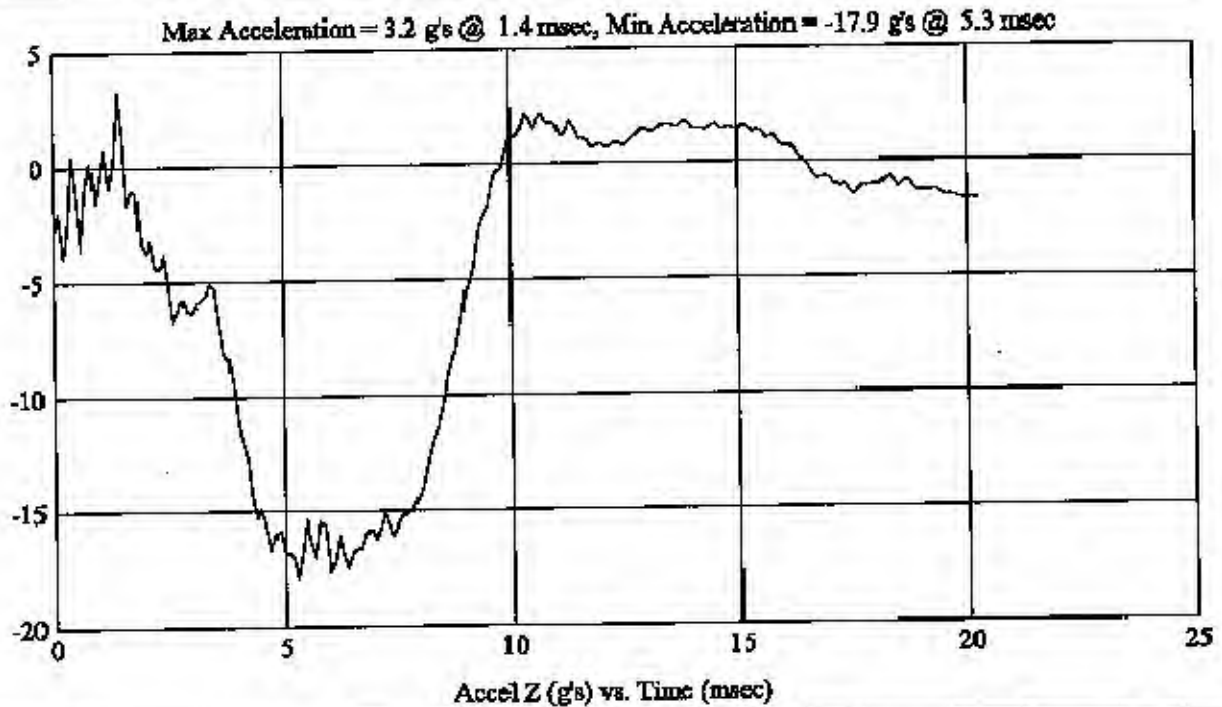
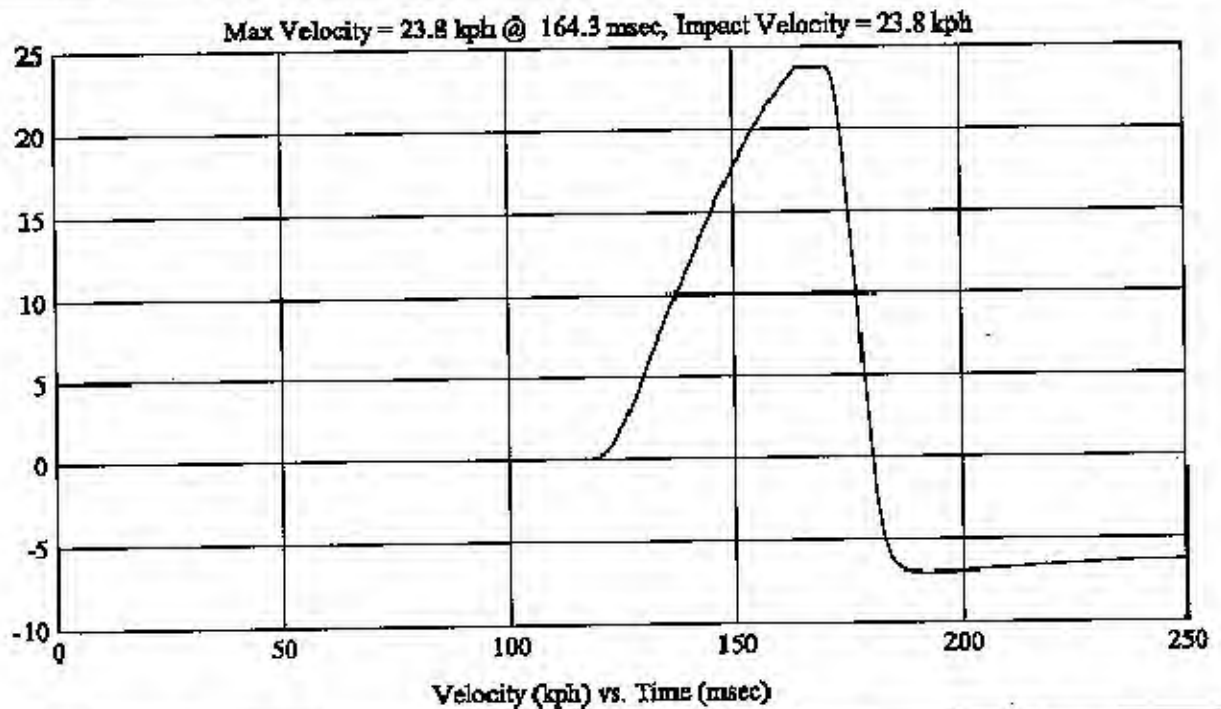
Model Year: 2005  
Target: BP3  
Vehicle Side: Left  
Horz/Vert Angle: 270/-2

HIC(d) = 594, HIC = 567, Delta T = 9.3 msec

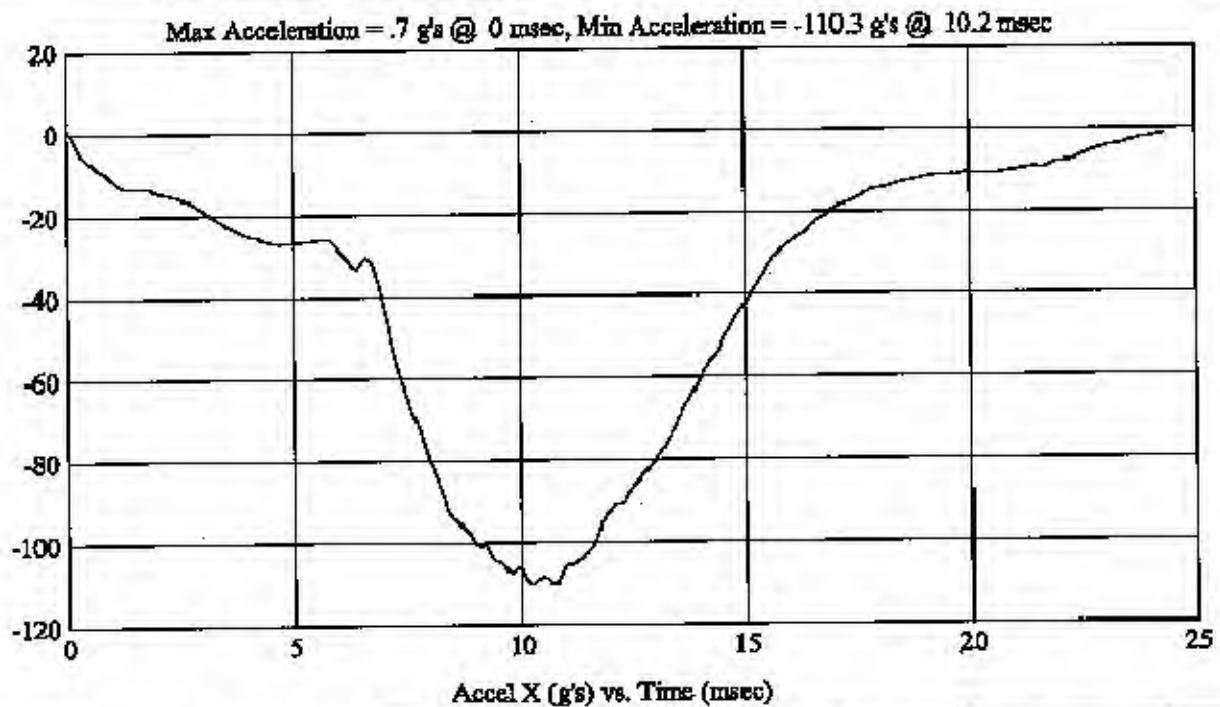
Model Year: 2005  
Target: OP2  
Vehicle Side: Right  
Horz/Vert Angle: 90/0

HIC(d) = 609, HIC = 587, Delta T = 7.1 msec

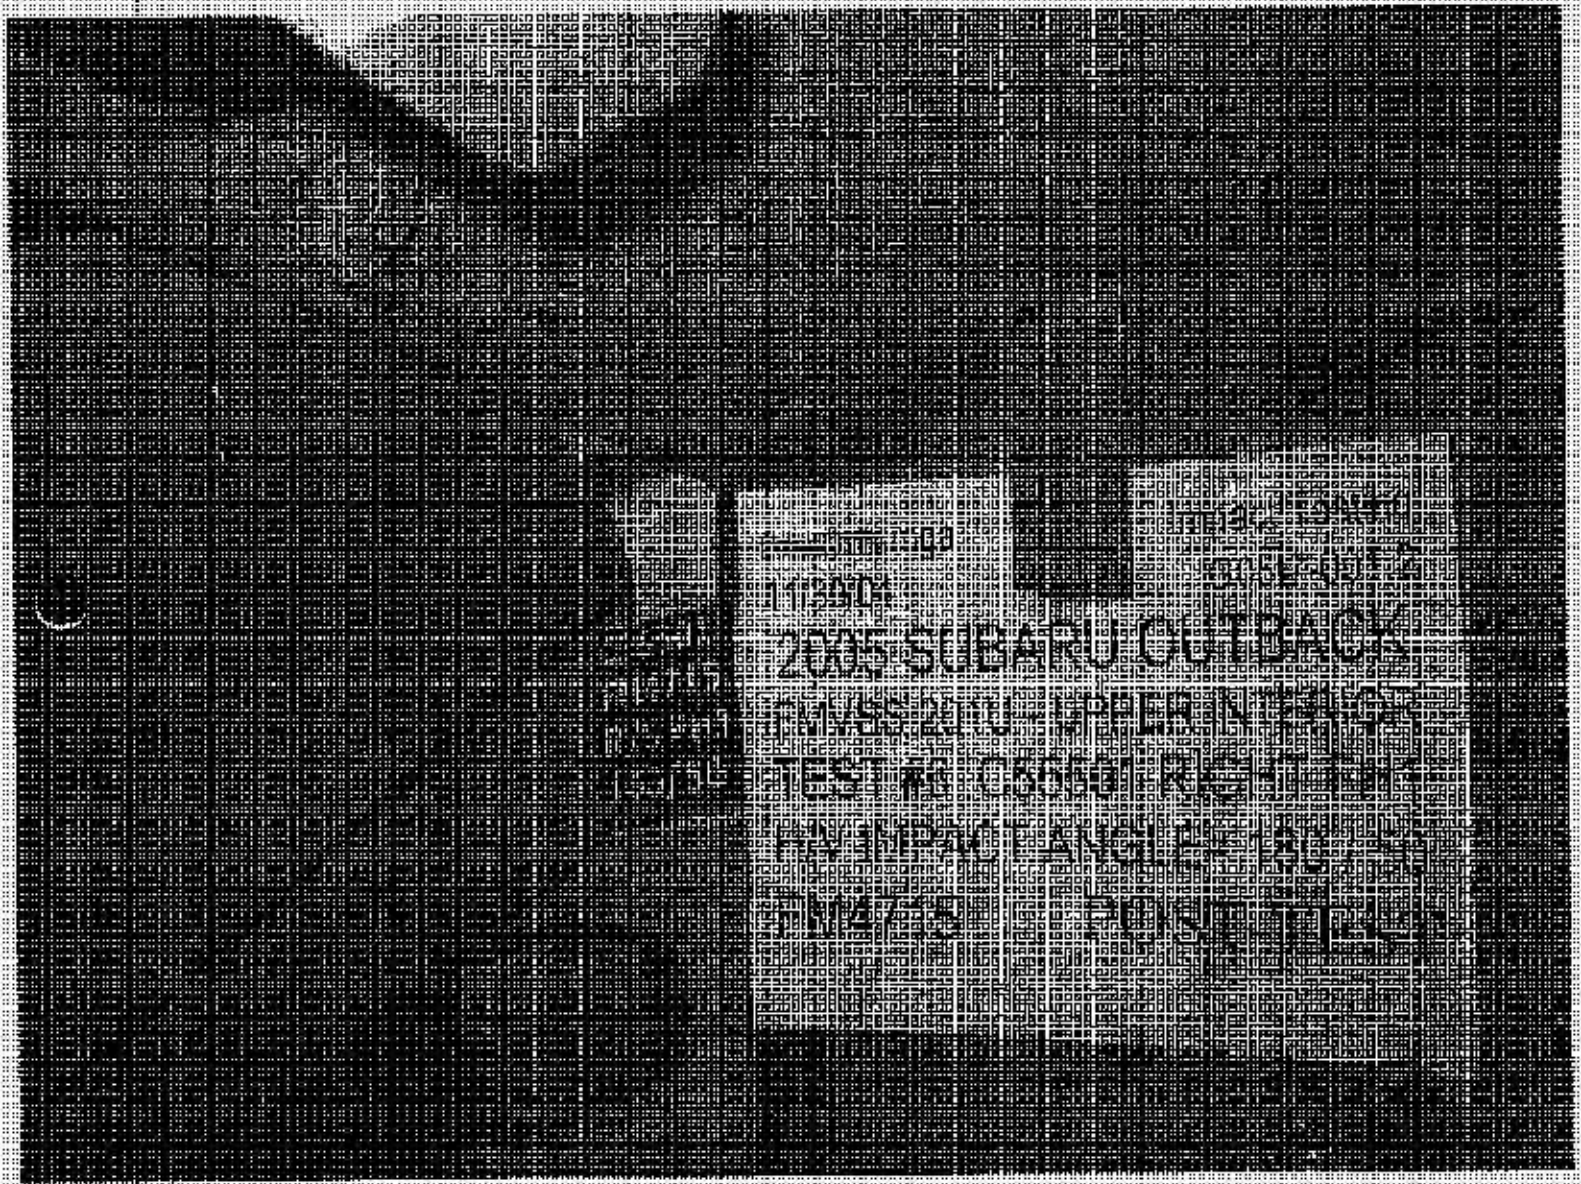
2005 SUBARU OUTBACK  
 PASS 2010 - UPPER INTERIOR  
 TEST 40 C55501 RIGHT FH1  
 IMPACT ANGLE = 180 DEG  
 PRE-TEST

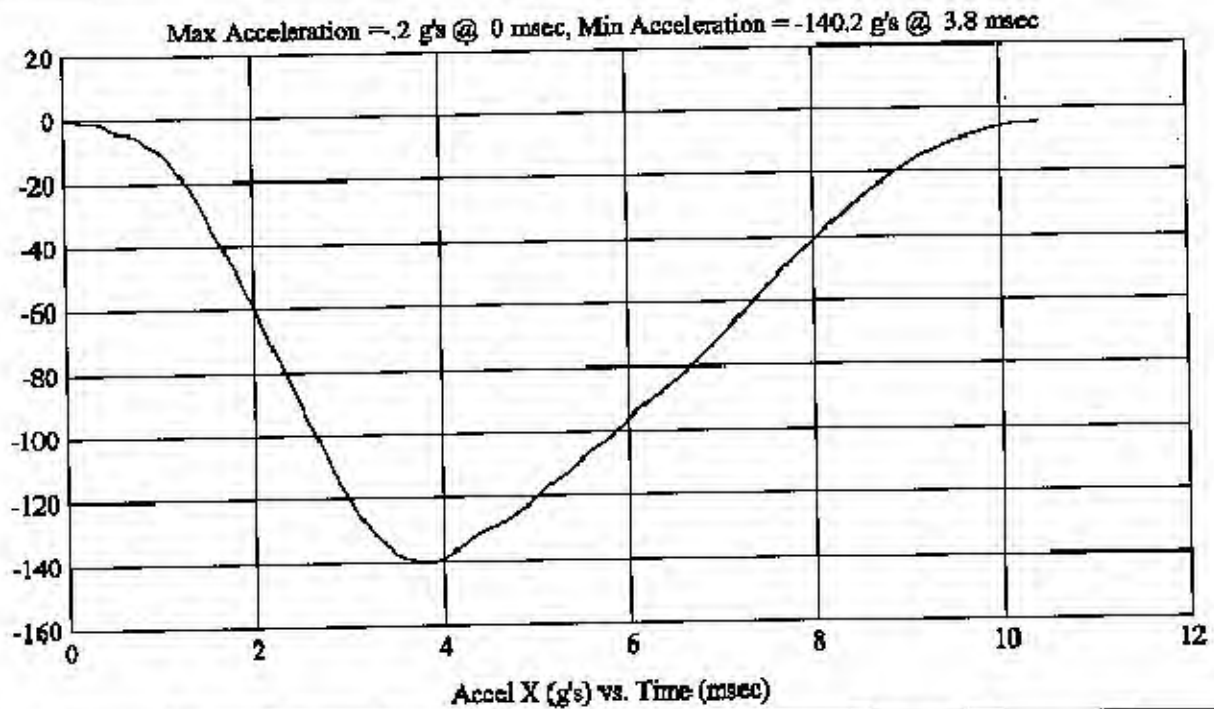
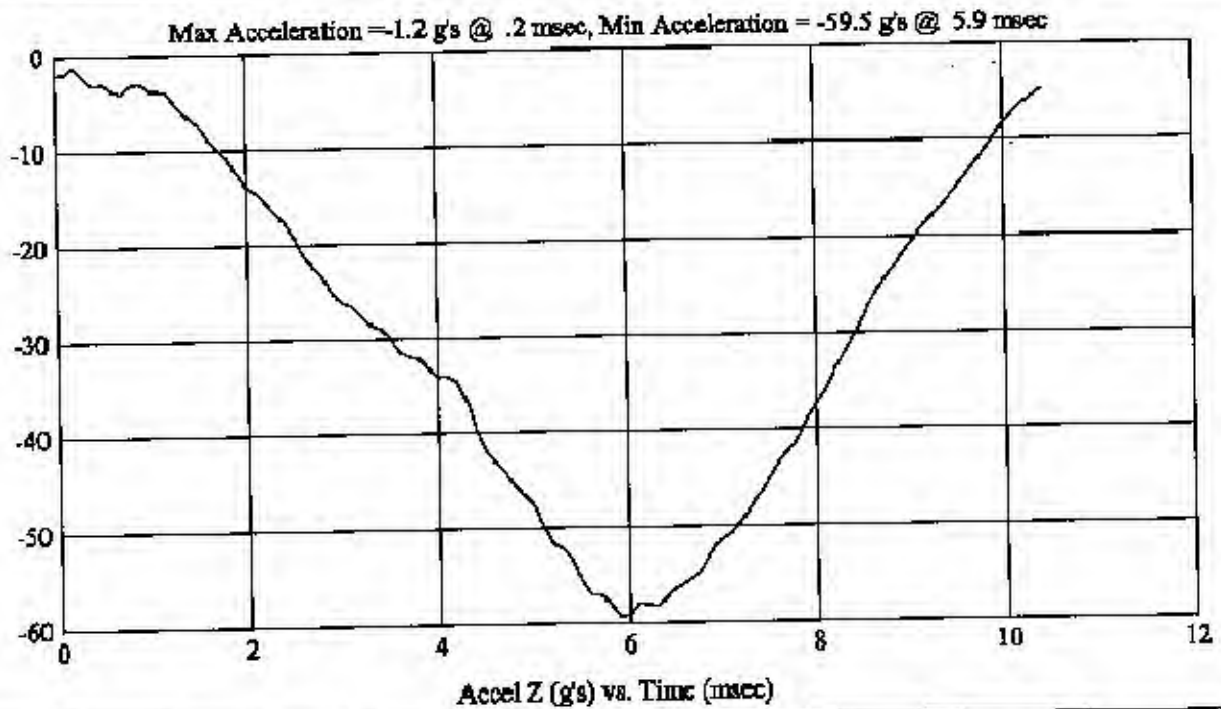
Model Year: 2005  
Target: FH1  
Vehicle Side: Right  
Horz/Vert Angle: 180/50

HIC(d) = 770, HIC = 800, Delta T = 5.4 msec

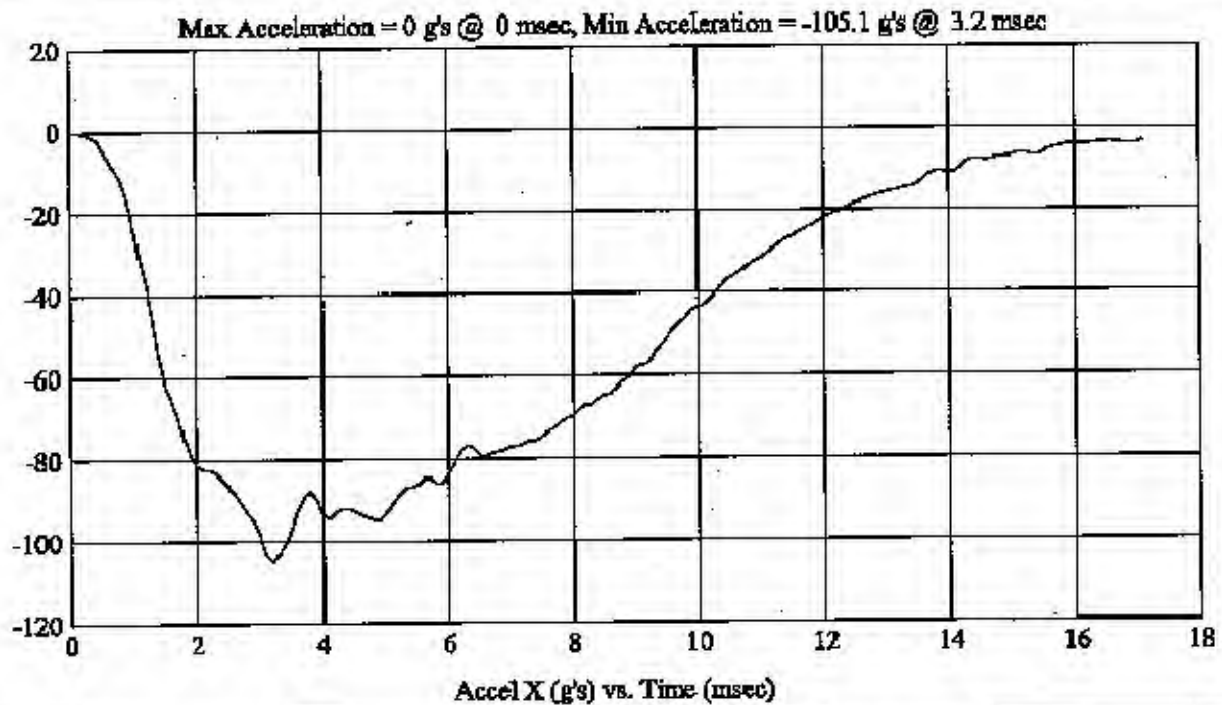
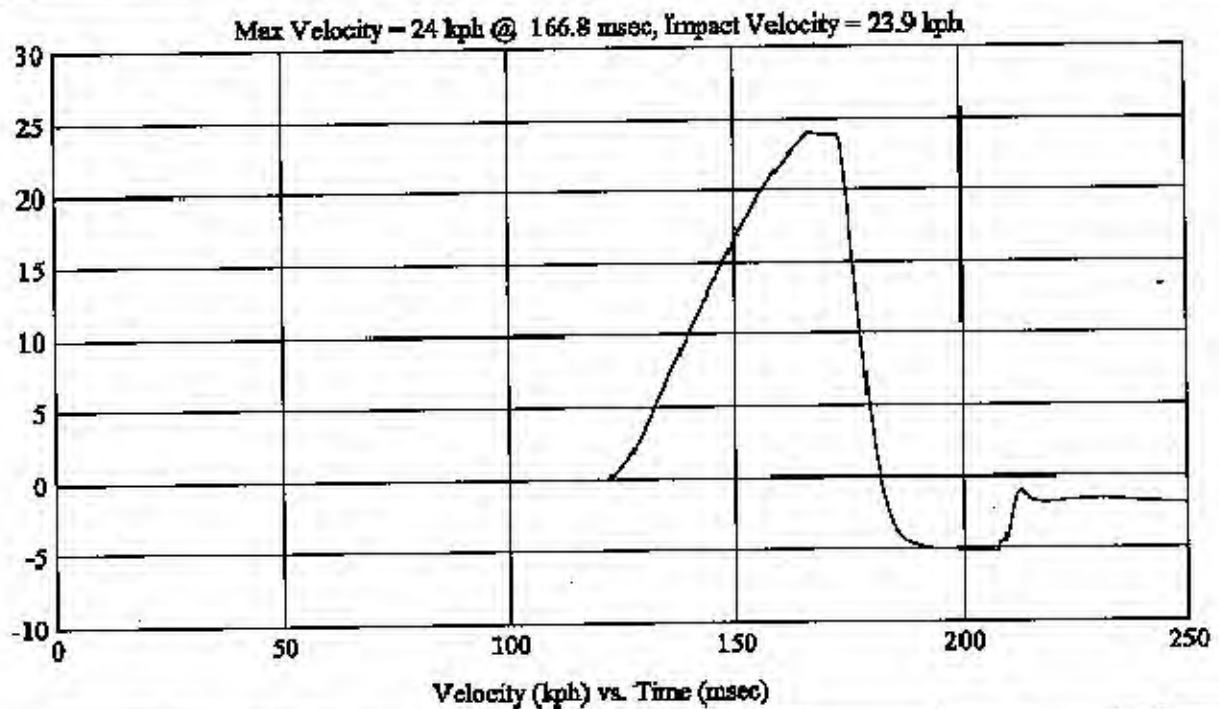
UR1 Left: Grab handle was broken during impact. Headliner deformation.

Grab Handle was broken during impact.

Model Year: 2005  
Target: UR1  
Vehicle Side: Left  
Horz/Vert Angle: 270/32

HIC(d) = 542, HIC = 498, Delta T = 8.9 msec

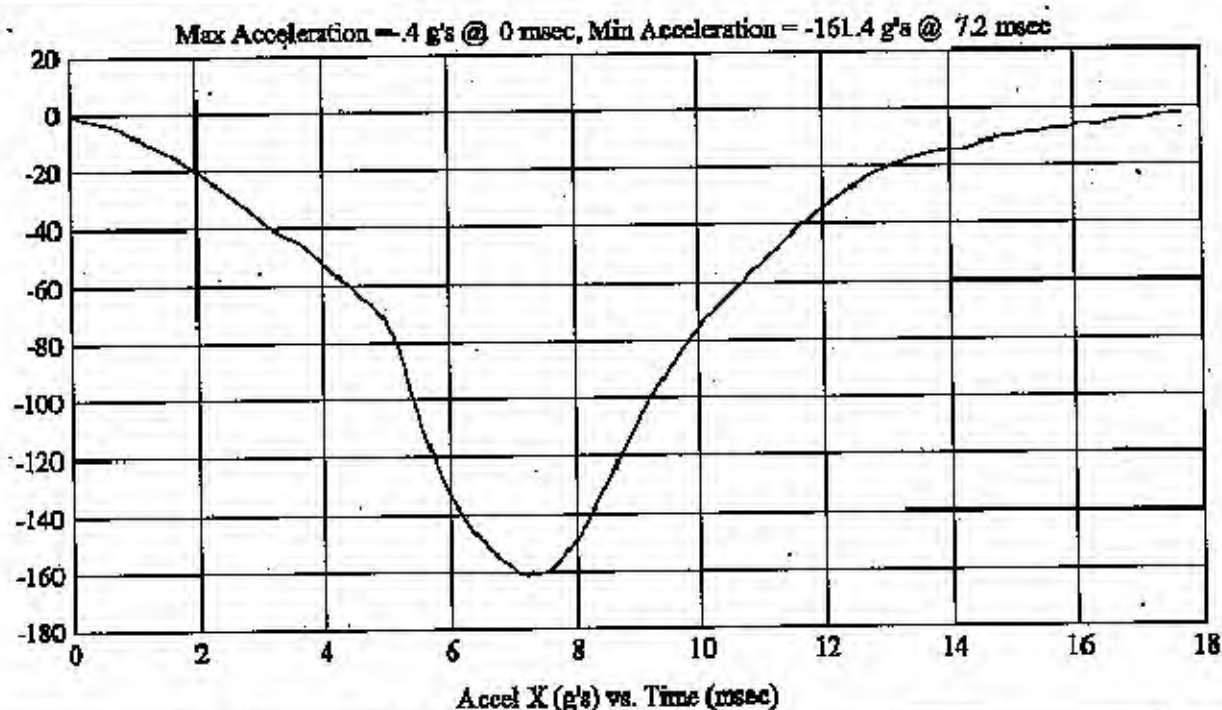
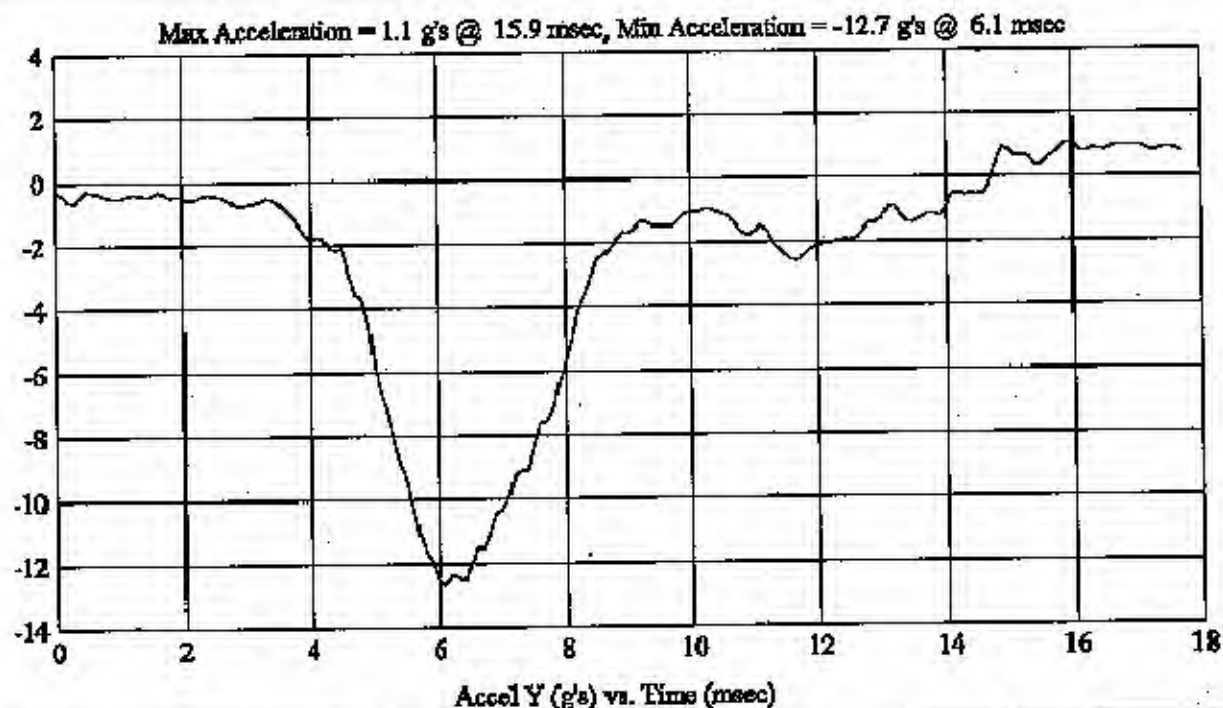
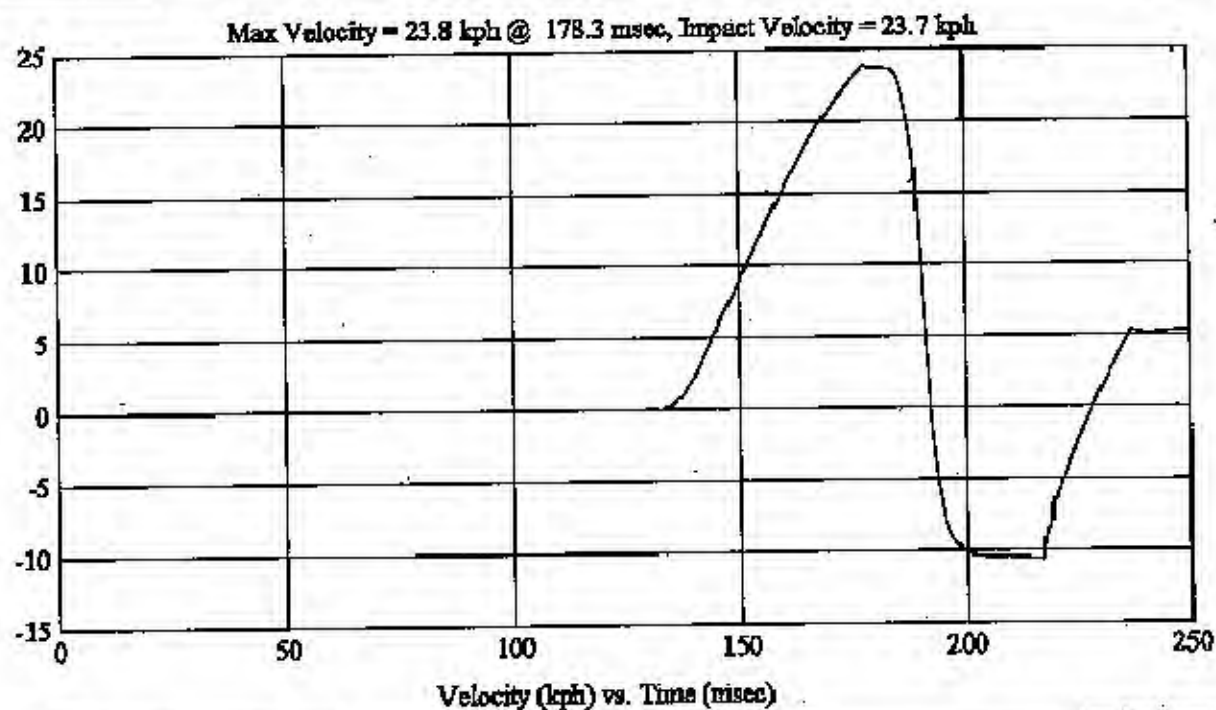
UR3 Left: Headliner deformation.

Model Year: 2005  
Target: UR3  
Vehicle Side: Left  
Horz/Vert Angle: 270/32 $HIC(d) = 847$ ,  $HIC = 902$ ,  $\Delta T = 4.9 \text{ msec}$

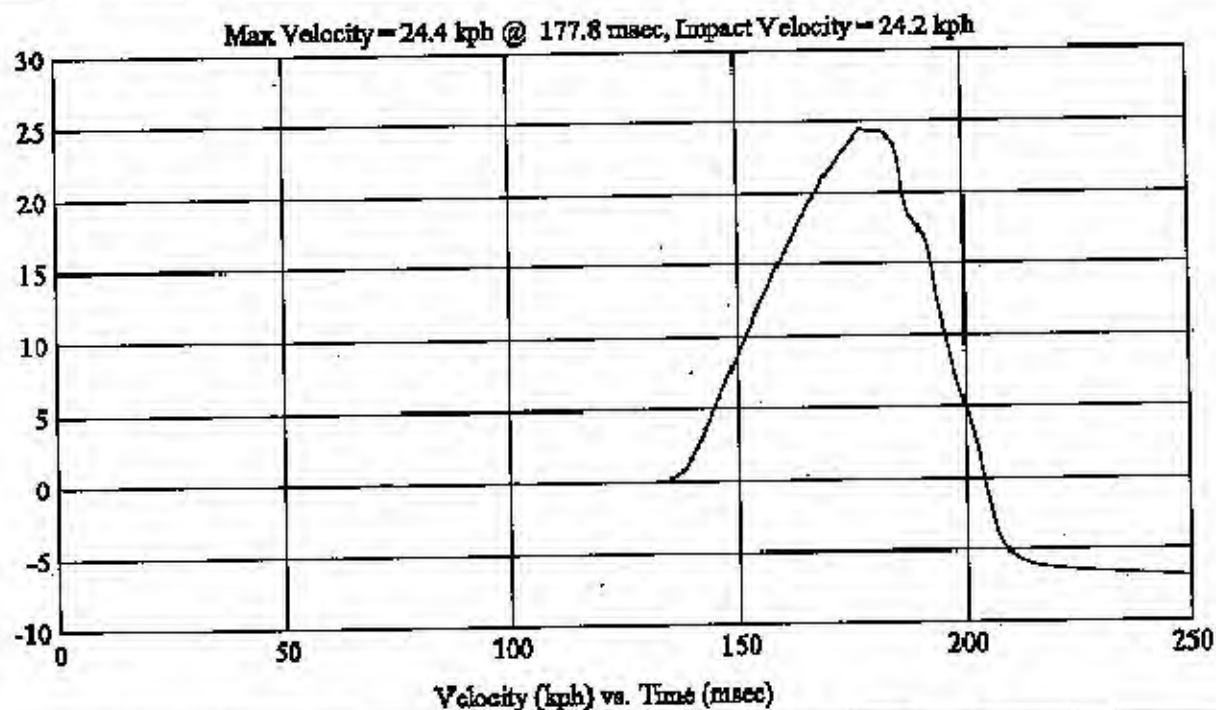
Model Year: 2005  
Target: UR4  
Vehicle Side: Right  
Horz/Vert Angle: 15/50 $HIC(d) = 308$ ,  $HIC = 188$ ,  $\Delta T = 23.3 \text{ msec}$

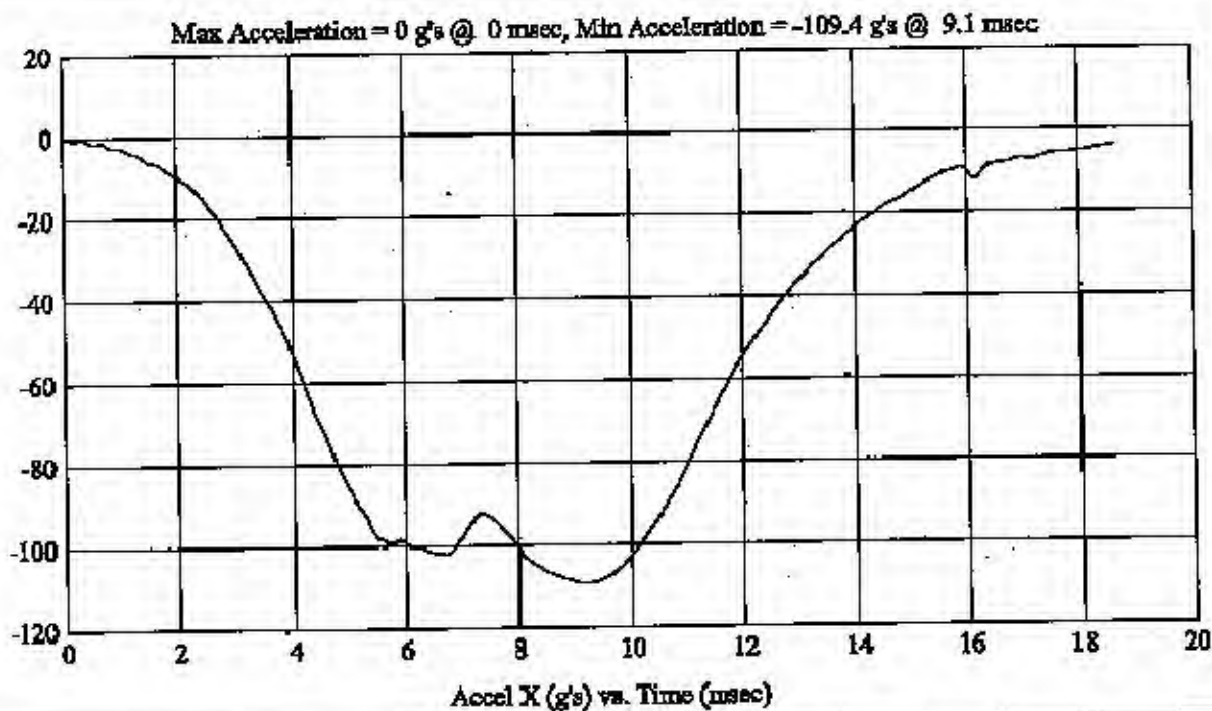
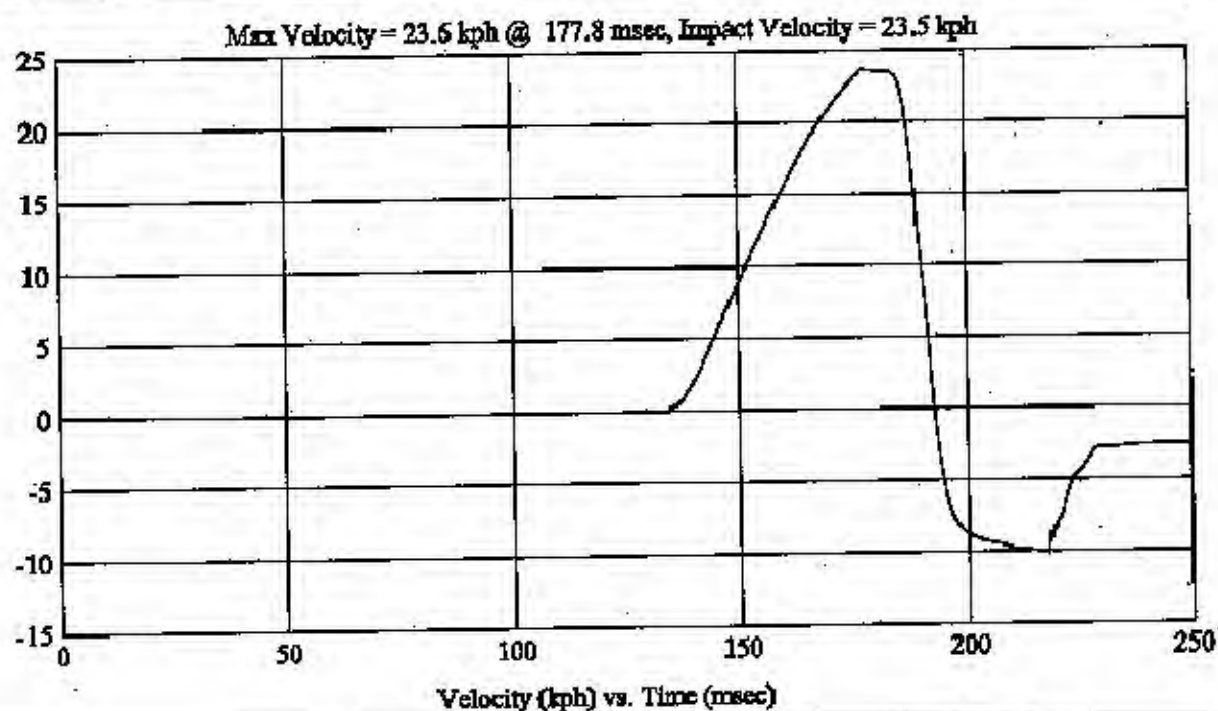
Model Year: 2005  
Target: UR5  
Vehicle Side: Right  
Horz/Vert Angle: 90/31

HIC(3) = 679, HIC = 679, Delta T = 7.8 msec
